## 1 Bailout manifold failure

## 2 Master links came free from lifeboat release hooks, releasing the lifeboat

**3 Three bolts sheared on a lifting trunnion**

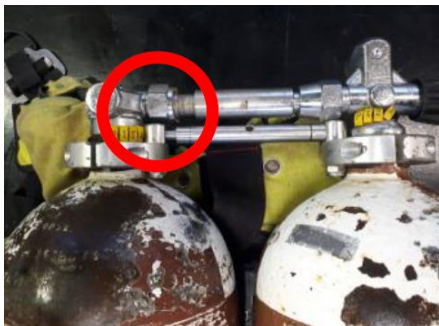
A little over an hour after the bell checks, the dive supervisor heard a sudden rush of gas over the comms. A check of the bell internal camera showed visible misting (as from a gas leak). Initial investigation led to the discovery of four pieces of a failed nut from the bailout manifold assembly.

*Bailout manifold assembly example showing location of failed nut*

Later forensic testing of the nuts from the manifold assembly supported the original root cause analysis which suggested that lateral force had likely been introduced due to inappropriate securing mechanisms. This led to stress corrosion cracking in the nut and allowed material ingress which caused internal corrosion over time.

- Replaced these particular bailout manifold assemblies with a more robust version currently in use elsewhere in the fleet;
- Ensure familiarity with planned maintenance tasks relating to bailout alignment, integrity and boots;
- Circulate to industry: the forensic analysis report indicates the nuts used are manufactured from copper alloy CW614N which is susceptible to stress corrosion cracking and dezincification. It is known that these are widely used on manifold assemblies in the industry.

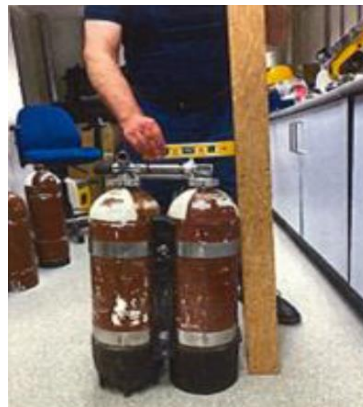
*Bailout set standing upright in uneven boots*

- The rubber boots of each cylinder were uneven, which would likely have led to stress being placed on one side when moved around;
- The securing strap holding the bottles together was found to be loose;
- The design of *this particular* bailout manifold was less robust than other systems used elsewhere by the company.

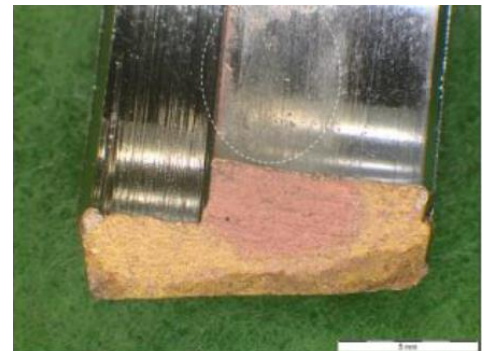
*Failed nut showing some signs of coating removal and corrosion at point of a stress fracture (pink area)*

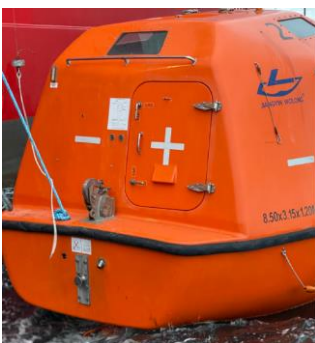
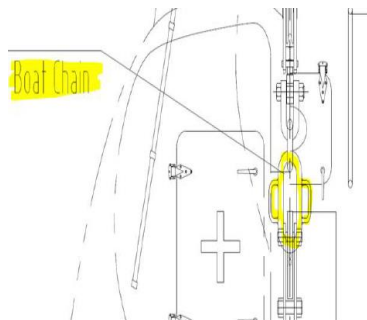
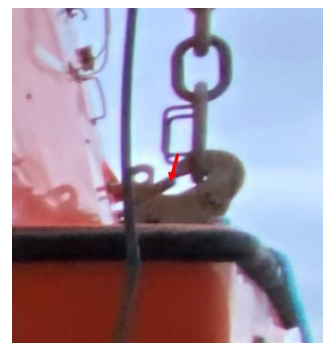
The location of the master link handles was incorrectly orientated with the handles facing inboard towards the hook latch and lifeboat. The movement of the master link handles therefore impacted and released the hook safety latch, releasing the hooks.

- Replacement master links with handles orientated to the sides to be installed.

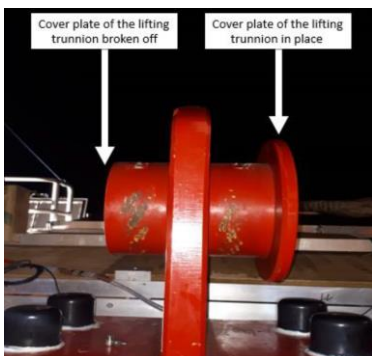
*Lifting trunnion*

After successful installation of a offshore renewables Transition Piece (TP), crew accessed the TP and discovered that the cover plate of the lifting trunnion had fallen off and was on the hatch cover of the TP with its three securing screws close by. The securing screws had sheared. The cover plate weighed 44kg and fell approximately 0.5m from the lifting trunnion to the hatch cover.

It was considered that the method of verifying the suitability of the screws attaching the cover plate to the lifting trunnions was incorrect. It was assumed that the sideway forces experienced by the cover plate were exactly introduced in the centre of the lug cover. However, this was not case. This assumption resulted in the inadequate method of securing the cover plate to the lifting trunnion.

- Weld the cover plates to the lifting trunnions.

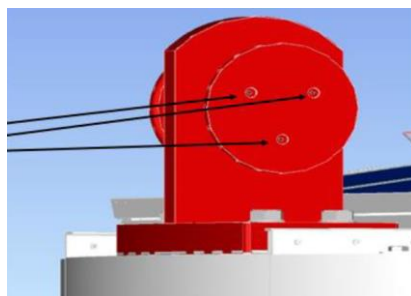
*Showing location of bolts*

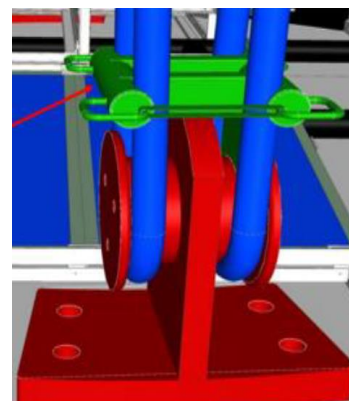
*Showing sling retainer*

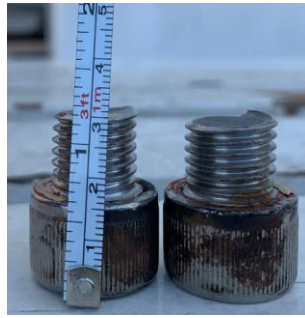
Sheared bolts

- The side forces experienced by the cover plate were greater than the screws could withstand; this could have been foreseen. Our member considers the root cause to be human error.

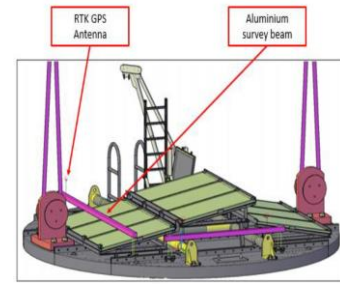
Further inspection followed and it was observed that there had been some damage to a survey beam and an antenna of GNSS positioning equipment. The damage caused to the antenna was fixed onboard. The survey lifting beamA had to be replaced, but there was a spare onboard and a replacement beam was ordered.

Diagram of damaged equipment

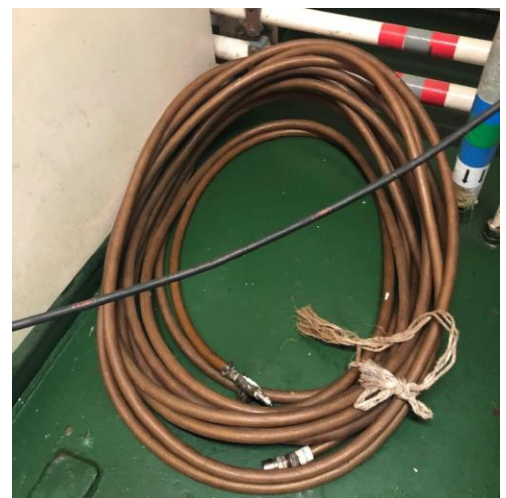
- The person who felt ill had also come into contact with the fluid; gloves were not worn as the assumption had been made that it was only water that was being dealt with;
- It was considered that the hose contained mostly stagnant water and some of the cooling medium liquid. The hose has been sat in a cupboard coiled up for *nearly two years* and was unlikely to have been allowed to drip dry at any point, leaving remnants of non-potable water and cooling medium inside;

Our member considered the root cause of the incident to be poor hose management. After investigation it was found that this hose had been previously used to fill up the system with Antifrogen, a cooling agent, in July 2019. It had not been properly flushed afterwards and some of the previous liquid had remained in the hose. The hose had not been used since.

- The old hose was disposed of. Two new hoses were prepared, one for cooling agent, the other for non-potable water;
- All such hoses to be flushed clean after use and left to dry before storage;
- Avoid touching a substance if you are not sure exactly what it is!
