## 1 Bailout manifold failure

## 2 Master links came free from lifeboat release hooks, releasing the lifeboat

**3 Three bolts sheared on a lifting trunnion**

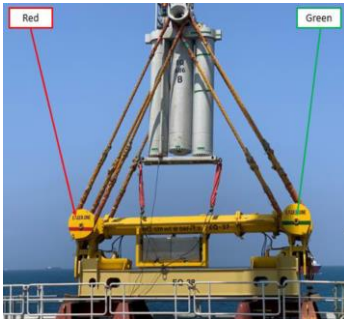
Further inspection followed and it was observed that there had been some damage to a survey beam and an antenna of GNSS positioning equipment. The damage caused to the antenna was fixed onboard. The survey lifting beamA had to be replaced, but there was a spare onboard and a replacement beam was ordered.

Similar lifting beam

It was considered that the method of verifying the suitability of the screws attaching the cover plate to the lifting trunnions was incorrect. It was assumed that the sideway forces experienced by the cover plate were exactly introduced in the centre of the lug cover. However, this was not case. This assumption resulted in the inadequate method of securing the cover plate to the lifting trunnion.

- The side forces experienced by the cover plate were greater than the screws could withstand; this could have been foreseen. Our member considers the root cause to be human error.

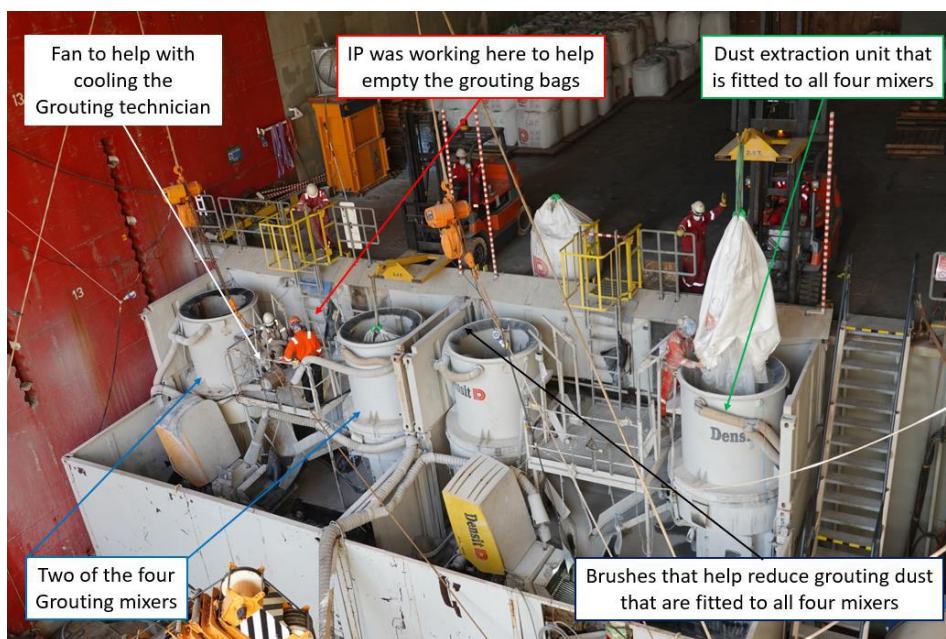
After completion of the grouting operation for an offshore wind farm transition piece, the sub-contract grouting team began cleaning their equipment using high pressure water jets. During this cleaning operation, one member of the team received first degree burns to his two knees and left calf. The team member suffered burns in three places and minor irritation spots elsewhere. The burns were treatable on board and had completely healed after three weeks.

*Grouting plant on vessel*

The investigation discovered that the person who was affected, had grouting dust on his coveralls when he started working with the water jet. Whilst he was using the water jet he got soaked to the skin with the water, and this water mixed with the grouting dust to make a corrosive solution which burnt his skin.

Our member considers that the root cause of this unfortunate incident was that the Safety Data Sheet for the grout lacked any information regarding the hazard of the grout dust *mixing with water* and becoming corrosive. This lack of hazard identification resulted in no risk mitigation measures being introduced to the risk assessment.
